## Tool Wear, Surface Integrity and Dimensional Accuracy in Turning Al<sub>2</sub>124SiCp (45%wt) Metal Matrix Composite using CBN and PCD Tools

**Abstract:** The focus of this study is the turning of Al<sub>2</sub>124SiCp (45% wt) Metal Matrix Composite using PCD, CBN-coated and CBN-uncoated tools. The machinability of Al<sub>2</sub>124SiCp (45% wt) Metal Matrix Composite is evaluated by measurement of tool wear, surface finish and dimensional accuracy of the work-piece. Wear mechanisms and patterns of tools in turning of Al<sub>2</sub>124SiCp (45% wt) Metal Matrix Composite are discussed. The experimental setup involved turning Al<sub>2</sub>124SiCp (45% wt) 78.0 mm long and 31.8 mm diameter on a precision lathe at fixed feed rate, different depth of cut and cutting speed using PCD, CBN-coated and CBN-uncoated tools. The reinforcement of the matrix consists of SiC 5-8 μm in diameter. Experimental results reveal that abrasion and adhesion presented the most prevalent mode of wear among all the tools. Fracture was observed among CBN tools while chipping on PCD tools. Flank and crater wear were observed in all tools with flank wear more prevalent in both CBN-coated and CBN-uncoated

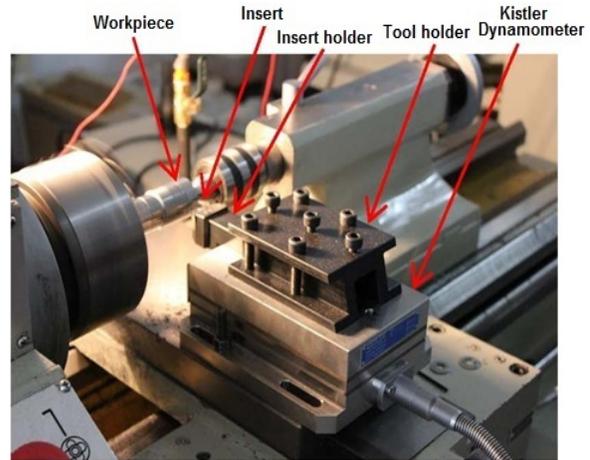
Fig. 1: Turning experiment set up

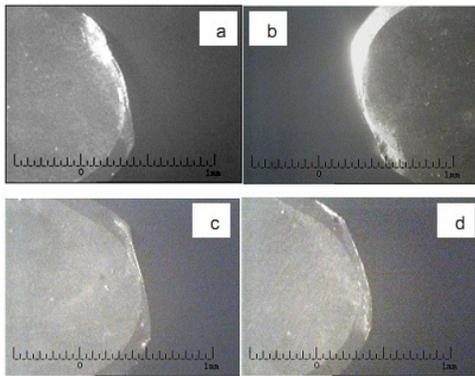
Fig. 2: Wear on CBN tool

**Wear mechanism:** There are many types of wear mechanisms that influence tool life. Under the current cutting conditions the main type of wear pattern physically observed was flank, crater, fracture and chipping wear. Figure 2, 3 and 4 show the various wear patterns on the three different tools. Comparing CBN-coated and CBN-uncoated tools it is observed that uncoated tools suffered more flank wear than coated tools. At low cutting speed the CBN-coated showed an amount of built-up edge Fig. 3a, b, c, d and f. At high cutting speed the flank wear of the tool increased tremendously with an increase in temperature at the tip. The wear of the tool also showed some fracture form of wear Fig. 3e. This could be attributed to the interaction between the tip and hard SiC particles. The rake surface of the tools suffered minimal damage since discontinuous chips were formed during the machining process. The rake surface suffered from abrasion wear by the hard SiC particles.

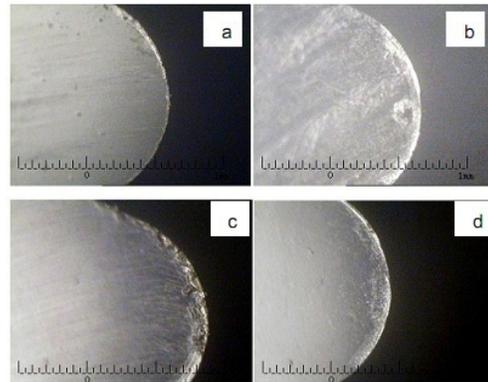
Fig. 4: Wear on PCD tool

quality as some of the matrix material is deposited of the work surface hence lowering surface quality. Abrasion is the dominant mode of wear of the tool where the first layer of coating is fast worn out in the initial machining. The worn tool reveals BUE on the cutting edge as shiny aluminum matrix material. In CBN-uncoated the tool shows BUE edge as the shiny part Fig. 2. The mode of wear is abrasion form of wear where the sharp cutting edge is worn off by the hard abrasive particles of SiC. For PCD tools dominant wear observed is flank wear Fig. 4. This wear is quite minimal and the tool retains the cutting edge for a long time as compared to CBN tools. Chipping is also evident in PCD tool which shows the worn cutting edge in form of a rugged edge Fig. 4. PCD tool further shows abrasive wear of the rake face in form of crater wear (Fig. 4a, b and c) this could be due to the rake angle of the PCD tool where the chips slide over the rake surface gouging out tool material. Among the three tools the shiny part shows built up edge on the cutting surface. It is observed that among the three tools PCD tool suffers lowest wear in the machining process and retains its cutting edge.

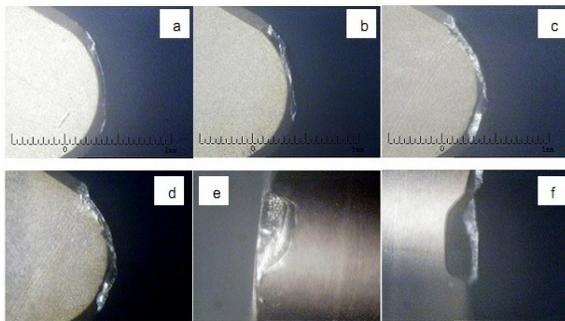
Fig. 3: Wear of CBNC tool

CBN-coated tool showed a relatively stable Built Up Edge (BUE) which enabled the tool to have longer tool life. However the BUE has an effect on the surface

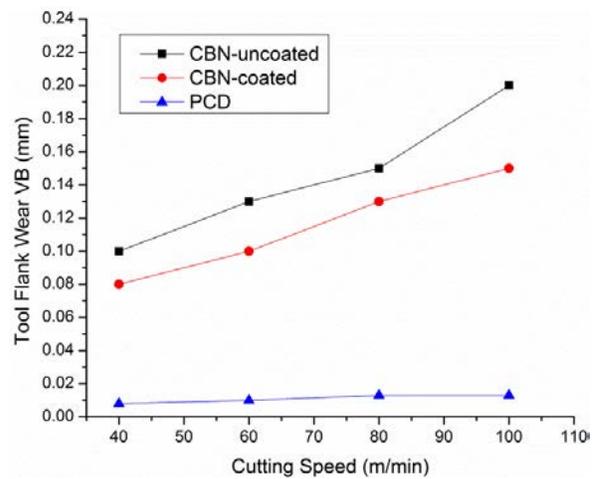
Fig. 5: Tool Wear at feed 8.3 mm/min and depth of cut  $a = 0.1$  mm

**Tool flank wear:** Figure 5 to 7 show the influence of cutting speed on flank wear of CBN-uncoated, CBN-coated and PCD tools during turning of turning of Al2124SiCp (45% wt) MMC. From the figures it is observed that at any particular feed an increase in cutting speed and depth of cut cause a corresponding increase in flank wear.

From Fig. 5, it can be observed that at depth of cut of 0.1 mm and feed of 8.3 mm/min flank wear for CBN tool is 0.1 mm at 40 m/min cutting speed which increases to 0.25 mm at cutting speed of 100 m/min. For the same depth of cut and feed the flank wear for CBNC is 0.08 mm at 40 m/min cutting speed which increases to 0.18 mm at 100 m/min. the flank wear for the PCD at all the speed is quite negligible ranging from 0.008mm at 40 m/min cutting speed increasing to 0.013 mm at 100 m/min cutting speed. A similar trend can be observed with an increase in depth of cut while maintaining the same feed rate. At the depth of cut of 0.2 mm and feed of 8.3 mm/min (Fig. 6) flank wear for CBN-uncoated tool is 0.13 mm at 40 m/min cutting speed which increases to 0.28 mm at cutting speed of 100 m/min. For the same depth of cut and feed the flank wear for CBN-coated is 0.1 mm at 40 m/min cutting speed which increases to 0.2 mm at 100 m/min. The flank wear for the PCD at all the speed is quite negligible ranging from 0.007 mm at 40 m/min cutting speed increasing to 0.012 mm at 100 m/min cutting speed. At the depth of cut of 0.3 mm and feed of 8.3 mm/min (Fig. 7) flank wear for CBN-uncoated tool is 0.13 mm at 40 m/min cutting speed which increases to 0.32 mm at cutting speed of 100 m/min. For the same depth of cut and feed the flank wear for CBN-coated is 0.12 mm at 40 m/min cutting speed which increases to 0.28 mm at 100 m/min. The flank wear for the PCD at all cutting speeds is quite negligible ranging from 0.006 mm at 40 m/min cutting speed increasing to 0.012 mm at 100 m/min cutting speed. It is observed that an increase in depth of cut causes an increase in flank wear which increase with increasing cutting speed. In all the cutting parameters it can be observed that PCD tool presents lowest flank wear over the total cutting time. From the findings it can be concluded that the depth of cut and cutting speed are significant on the tool flank wear during machining of Al2124SiCp (45% wt) MMC.

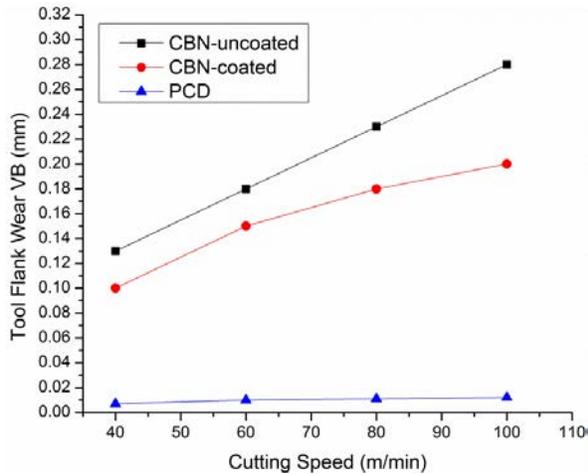
Fig. 6: Tool Wear at feed 8.3 mm/min and depth of cut a = 0.2 mm

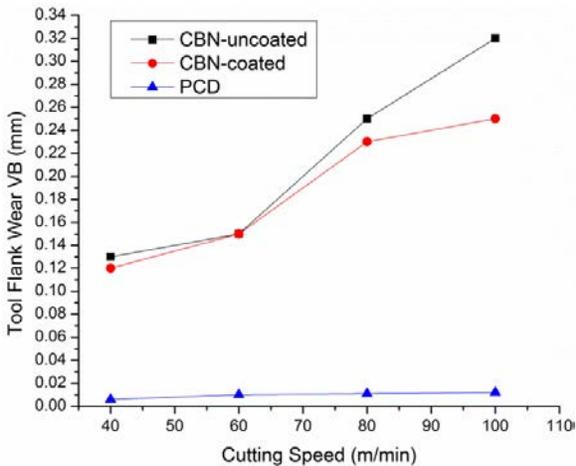
Fig. 7: Tool Wear at feed 8.3 mm/min and depth of cut a = 0.3 mm

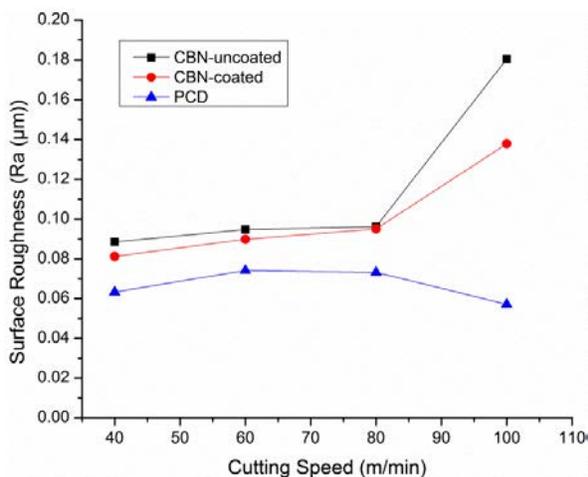
Fig. 8: Surface roughness at feed 8.3 mm/min and depth of cut a = 0.1 mm

**Surface roughness:** Figure 8 to 10 show the influence of cutting speed and depth of cut on surface roughness Ra of CBN-uncoated, CBN-coated and PCD tools during turning of Al2124SiCp (45% wt) MMC. From the figures it is observed that at any particular feed an increase in cutting speed causes a corresponding increase in surface roughness with exception of PCD tool.

From Fig. 8, it can be observed that at depth of cut of 0.1 mm and feed of 8.3 mm/min surface roughness

for CBN-uncoated tool is 0.1038  $\mu\text{m}$  at 40 m/min cutting speed which increases to 0.1804  $\mu\text{m}$  at cutting speed of 100 m/min. For the same depth of cut and feed the surface roughness for CBN-coated is 0.0812  $\mu\text{m}$  at 40 m/min cutting speed which increases to 0.1378  $\mu\text{m}$  at 100 m/min. The surface roughness for the PCD at all the speed is relatively low ranging from 0.0632  $\mu\text{m}$  at 40 m/min cutting speed decreasing to 0.0571  $\mu\text{m}$  at 100 m/min cutting speed. At the depth of cut of 0.2 mm and feed of 8.3 mm/min (Fig. 9) surface roughness for CBN-uncoated tool is 0.0989  $\mu\text{m}$  at 40 m/min cutting speed which increases to 0.1931  $\mu\text{m}$  at cutting speed of 100 m/min. Surface roughness for CBN-coated is 0.0825  $\mu\text{m}$  at 40 m/min cutting speed which increases to 0.1423  $\mu\text{m}$  at 100 m/min. The surface roughness for the PCD is quite negligible ranging from 0.0695  $\mu\text{m}$  at 40 m/min cutting speed decreasing to 0.0751  $\mu\text{m}$  at 100m/min cutting speed. At the depth of cut of 0.3 mm and feed of 8.3 mm/min (Fig. 10) surface roughness for

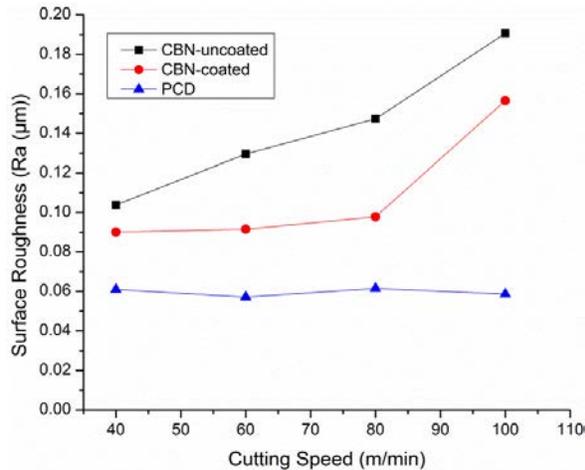
Fig. 9: Surface roughness at feed 8.3 mm/min and depth of cut a = 0.2 mm

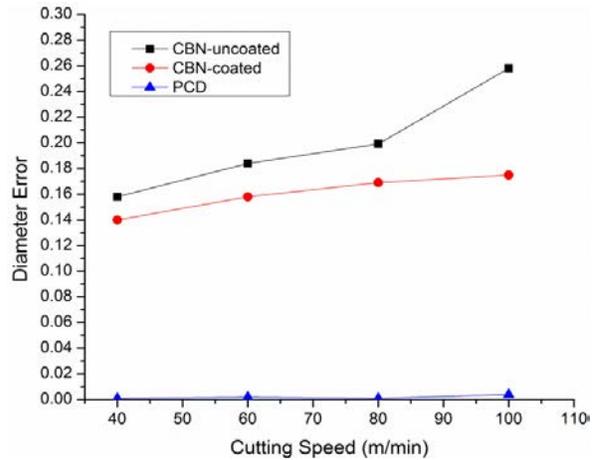
Fig. 11: Diameter error at feed 8.3 mm/min and depth of cut a = 0.1 mm

**Dimensional accuracy:** Figure 11 to 13 show the influence of cutting speed and depth of cut on diameter

error of CBN-uncoated, CBN-coated and PCD tools during turning of Al<sub>2</sub>124SiCp (45% wt) MMC. From the figure it can be observed that at any particular feed an increase in cutting speed causes a corresponding increase in diameter error with exception of PCD tool.

From Fig. 11, it can be observed that at depth of cut of 0.1 mm and feed of 8.3 mm/min diameter error for CBN-uncoated tool is 0.158 at 40 m/min cutting speed which increases to 0.258 at cutting speed of 100m/min. For CBN-coated tool it is 0.14 at 40 m/min cutting speed which increasing to 0.175 at 100 m/min. For the PCD tool the error is negligible at all cutting speeds ranging from 0.001 at 40 m/min cutting speed increasing to 0.004 at 100 m/min cutting speed. At the depth of cut of 0.2 mm and feed of 8.3 mm/min (Fig. 12) diameter error for CBN-uncoated tool is 0.14 at 40 m/min cutting speed which increases to 0.1721 at cutting speed of 100 m/min. For CBN-coated tool it is 0.13 at 40 m/min cutting speed which increases to 0.1535 at 100 m/min. For the PCD tool it is negligible ranging from 0.005 at 40 m/min cutting speed decreasing to 0.003 at 100 m/min cutting speed. At the depth of cut of 0.3 mm and feed of 8.3 mm/min (Fig. 13) diameter error for CBN-uncoated tool is 0.297 at 40 m/min cutting speed which increases to 0.5989 at cutting speed of 100 m/min. For the CBN-coated tool it is 0.238 at 40 m/min cutting speed which increases to 0.4097 at 100 m/min. For the PCD tool it is negligible ranging from 0.002 at 40 m/min cutting speed increasing to 0.004 at 60 and 80m/min cutting speed but at 100 m/min the error decreases to 0.002. In all the cutting parameters it can be observed that PCD tool presents lowest diameter error over the total cutting time. From the experimental results it can be concluded that the depth of cut and cutting speed are more significant on the diameter error during machining of Al<sub>2</sub>124SiCp (45% wt) Metal Matrix Composite.

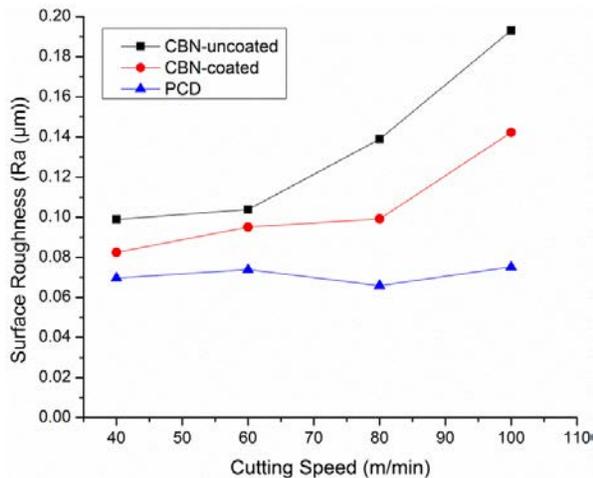
Fig. 10: Surface roughness at feed 8.3 mm/min and depth of cut a = 0.3 mm

CBN-uncoated tool is 0.1038  $\mu\text{m}$  at 40 m/min cutting speed which increases to 0.1906  $\mu\text{m}$  at cutting speed of 100 m/min. That for CBN-coated is 0.0901  $\mu\text{m}$  at 40 m/min cutting speed which increases to 0.1565  $\mu\text{m}$  at 100 m/min. For PCD, surface roughness is quite negligible ranging from 0.0609  $\mu\text{m}$  at 40 m/min cutting speed decreasing to 0.0586  $\mu\text{m}$  at 100m/min cutting speed. It is observed that an increase in depth of cut causes a corresponding increase in surface roughness which increases with increasing cutting speed. However this is not the case observed with PCD tool where at an increase in cutting speed shows an improved surface finish. In all the cutting parameters it can be observed that PCD tool presents lowest surface roughness over the total cutting time. From the results it can therefore be concluded that the depth of cut and cutting speed are significant on the surface roughness during machining of Al2124SiCp MMC.

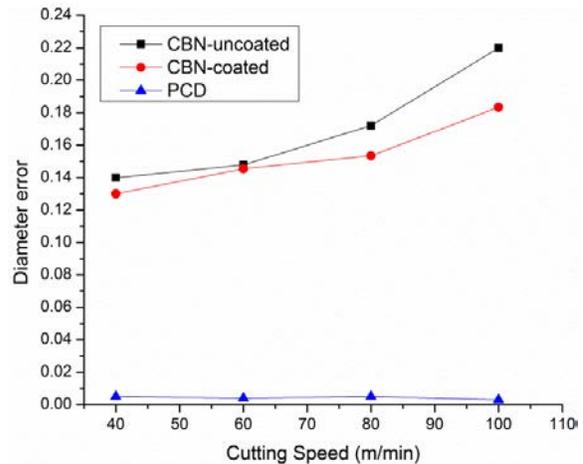
Fig. 12: Diameter error at feed 8.3 mm/min and depth of cut a = 0.2 mm

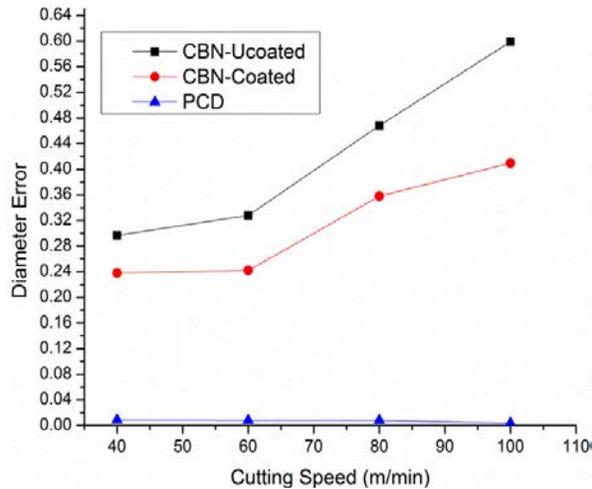
Fig. 13: Diameter error at feed 8.3 mm/min and depth of cut  $a = 0.3$  mm
